# COLORADO COUNTY COURTHOUSE MASTER PLAN

Columbus, Texas

VA Project No: 013-07  
September 14, 2007

# EXECUTIVE SUMMARY

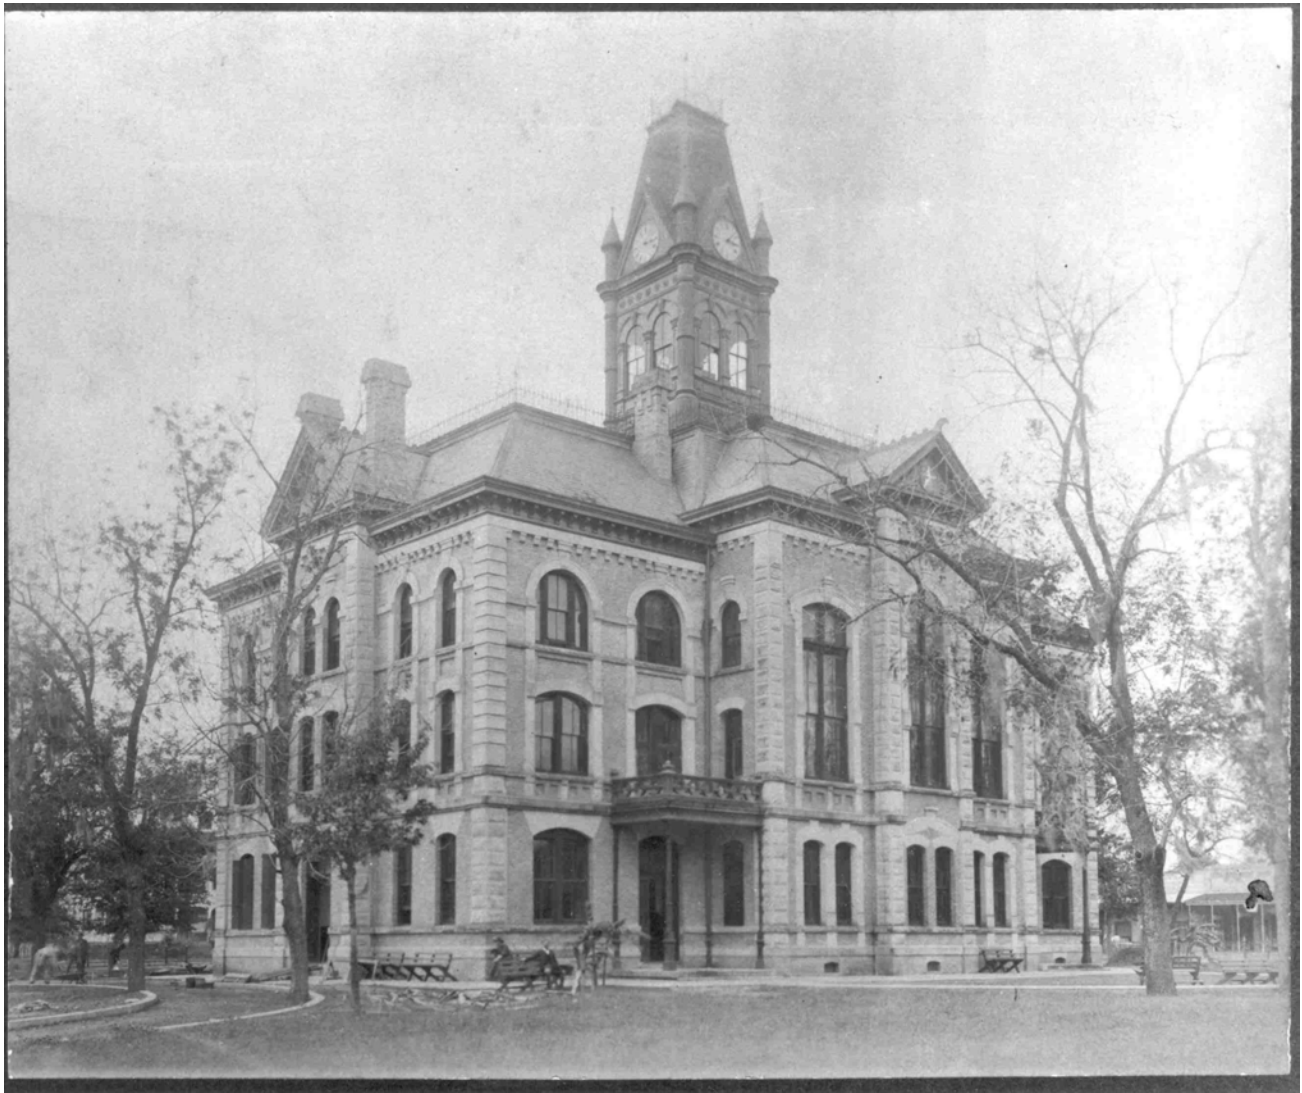
Historic Photo 6: Colorado County Courthouse, c. 1900, photographed from the northwest corner of the square (Original photograph in Big Pictures Box 1 File 21)

Comments: view is from northeast corner  
shows original tower, roof form, cornice, clock face, and roof cresting  
shows original balcony railings at porches  
shows semi-circular drive at east side (possibly under construction)
